# Malaysia Country Report 2010

**ABSTRACT:** This paper reviews domestic activities in the wind engineering field in Malaysia in 2010. It includes activities from several agencies and organization in Malaysia. Furthermore this paper also highlights recent damage and injuries due to wind storm.

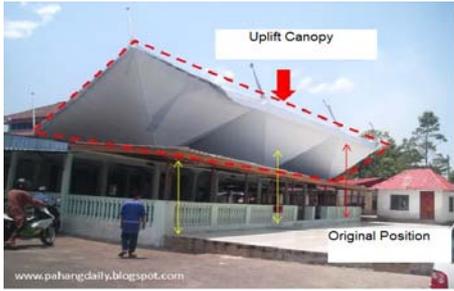
Figure 1a: Uplift canopy

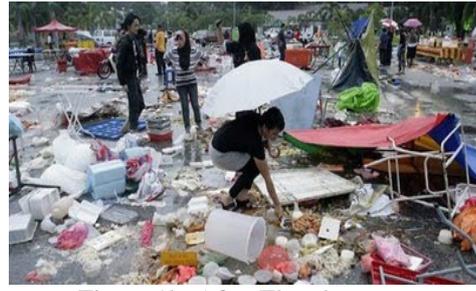
Figure 1b: After Thunderstorm

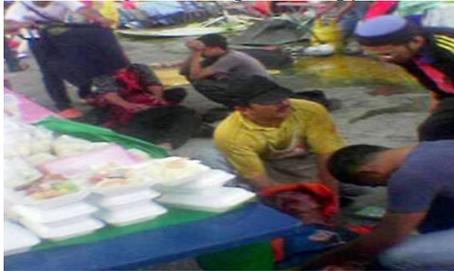
Figure 1c: Injuries peoples

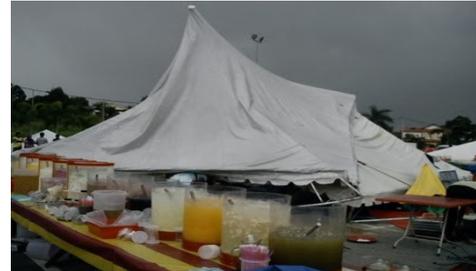
Figure 1d: Canopy Collapse

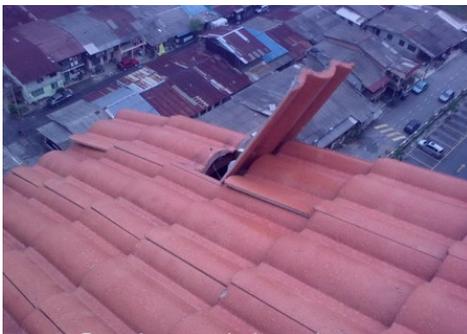
There are also many instances of partial lift off clay tiles fixed at eaves of roof and at ridge corner. From the investigation made damage to the tile roofs increase with the simplification of the substandard, i.e. decreasing the weight of roof tile, insufficient of nail fixed to the roof tile and the less of lay between the roof tiles.

Figure 2a: Uplift Roof Tile

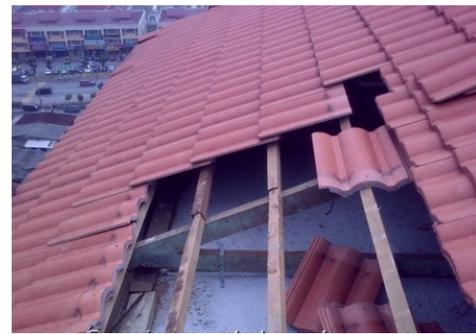
Figure 2b: Damage Roof Tile

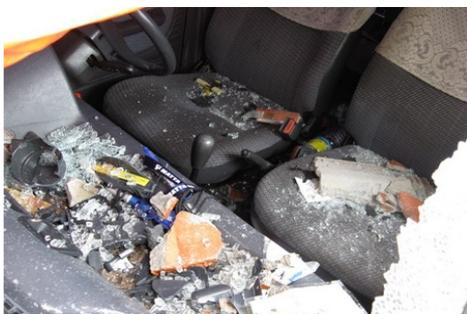
Figure 2c: Damage Due Flying Debris

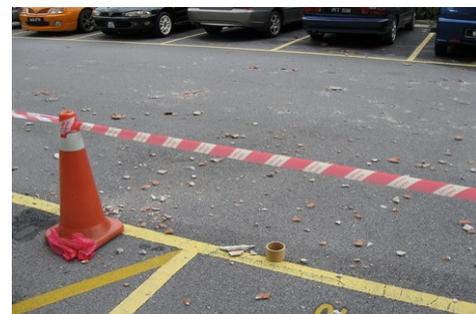
Figure 2d: Flying Debris of Roof Tile

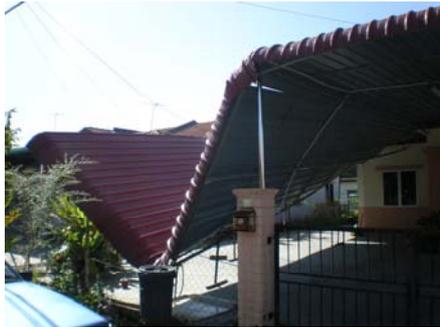
From the previous investigation due to recent damage it seems that the wind speed is mostly high compared to basic wind speed recommended. An investigation found that a triggering failure of steel truss structure of porch shown in figure 3 a- d reflecting a wind speed of  $38 \text{ m/s}$  [2]. Since this location is situated at northern region of peninsular Malaysia which is bordering to the Thailand Country in Zone 4a and Zone 4b. The Thailand code where referred

In Thailand code [4] the basic wind speed for the southern region which is classifies as zone 4a is  $25 \text{ m/s}$  base one-hour average speed at  $10 \text{ m}$ . If this wind speed converted to 3 second gust it will be equal to  $37.5 \text{ m/s}$ . This result is almost identical to wind speed identified to cause the failure to the structure. The Thailand code also recommended the typhoon factor equal to 1.2. Therefore from investigation of the failure and comparison of basic wind speed to the bordering country it shown basic wind speed in northern region in MS 1553:2002 given a low value compare to by

Figure 3a. Collapse Porch

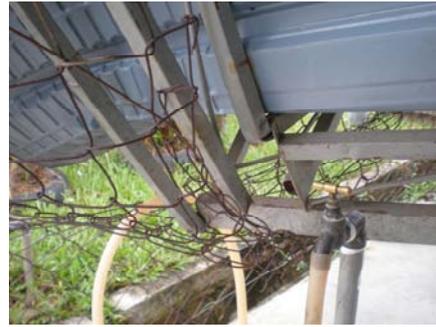
Figure 3b: Bending failure of Steel truss

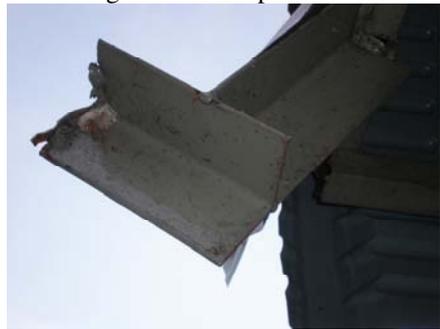
Figure 3c: Ultimate Load Failure

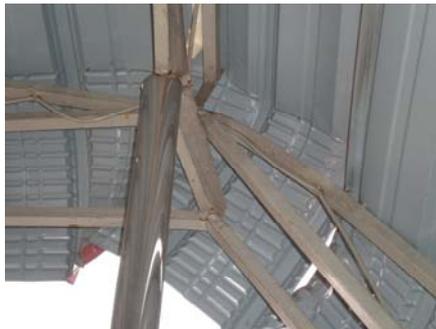
Figure 3d: Bending failure

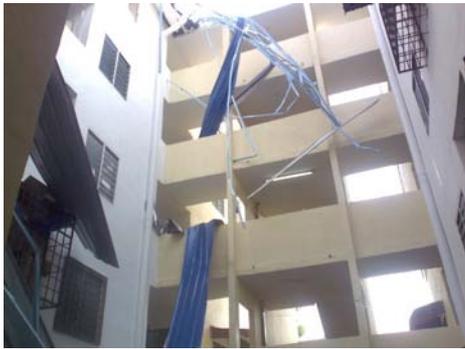
The possibility risk of wind load damage to roof structure. Conventionally in Malaysia most of the roof design only considered wind load acting as a pressure load to the roof structure. However from the many research done it seem that wind also can cause suction load to the building structure. Most damage to roofs themselves is caused by local high suction and large pressure fluctuations around the roof periphery and protruding portions. [ ]Tamura . In Malaysia the most of truss system used as roof structure is steel and wood. Steel truss structure is commonly used almost at urban area and considered as engineered building while wood frame truss always used at rural area which is almost are non-engineered building. Recently both of the structure system fails during the thunderstorm. Figure 6 a-e shows recent damage due to thunderstorm event. Currently study is conduct to examine whether the

Figure 6a – Steel Truss failure

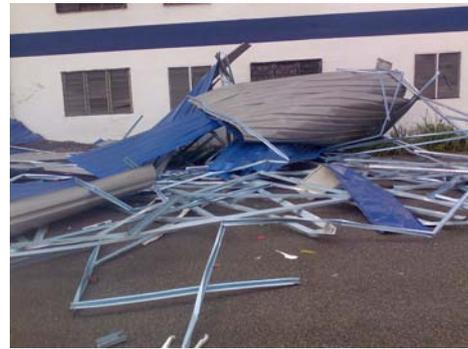
Figure 6b – Steel Truss failure

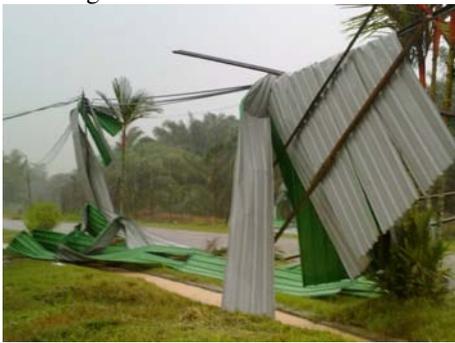
Figure 6c – Roof Sheet Failure

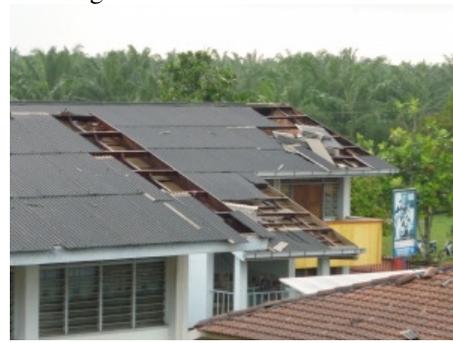
Figure 6d – Roof Damage

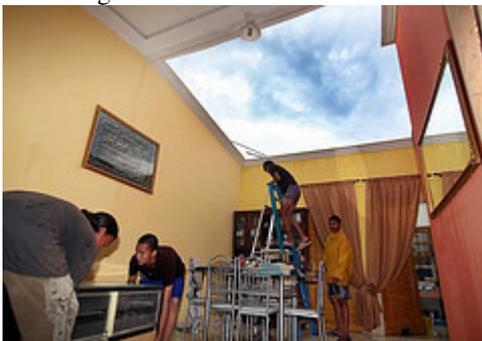
Figure 6e – Uplift Damage Roof

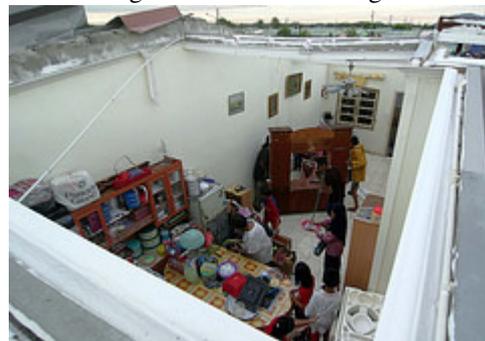
Figure 6f – Uplift Damage Roof Truss
